## **THERMOGRAPHIC MEASUREMENT REPORT**

Assessed for: FIRST Heating s.r.o., Revoluční 3, Praha 1, Czech Republic

Observed at: PROBAEQ s.r.o., Vrahovická 41, Prostějov, Czech Republic

The objective was to determine the heating properties of infrared heating panels manufactured by FIRST Heating. Two measurements were performed:

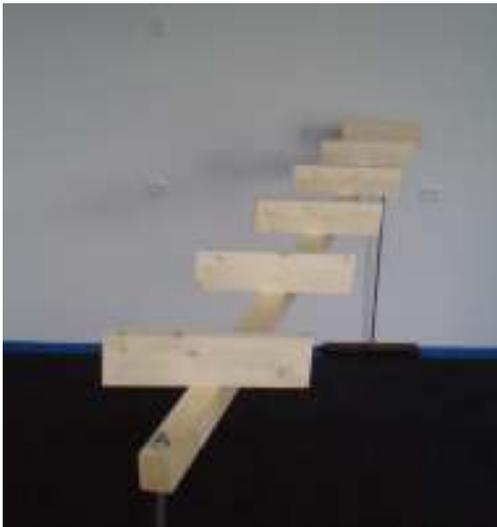
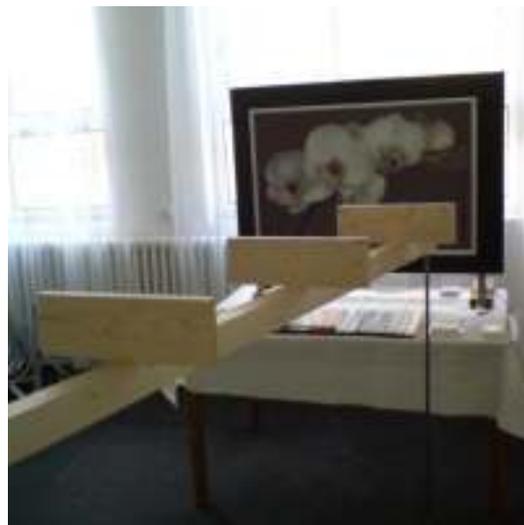
Figure 3 – Arrangement of the objects for evaluation, thermographic samples.

Temperature measurements were made on wooden boards (see Figure 3 below).

Six individual boards were spaced at distances of 0.5m from each other in a row, beginning at 0.5m from the heating panel. The temperatures of the boards were recorded every 5 minutes for a period of 120 minutes. A 600mm x 900mm heating panel was used in this observation. Measurements were performed with a thermal camera and contact thermometer. The results are listed in Table 2, the graph of temperatures in Figure 4, and in the Annex of thermal images.

It is evident from the measurement results that the greatest temperature increase (about 5°C) occurred within the first 20 minutes. Further increase of temperature slowed for the remainder of the evaluation to about 2°C.

All of the boards up to a distance of 3m gained temperature. Some then had slight reductions of temperature near the end of the measurement. The final temperature difference between boards nearest and most distant from the heating panel was nearly 3°C.
